**PHASE II ENVIRONMENTAL SITE ASSESSMENT  
FOR  
LITTLE GEYSERS CHILD CARE CENTER  
603 YELLOWSTONE AVENUE  
WEST YELLOWSTONE, MONTANA 59758**

Date Prepared	August 2016
TDD No.	0003/1602-07
Document Control No.	W0321.1A.00969
Contract No.	EP-S8-13-01
U.S. EPA Work Assignment Manager	Tim Rehder

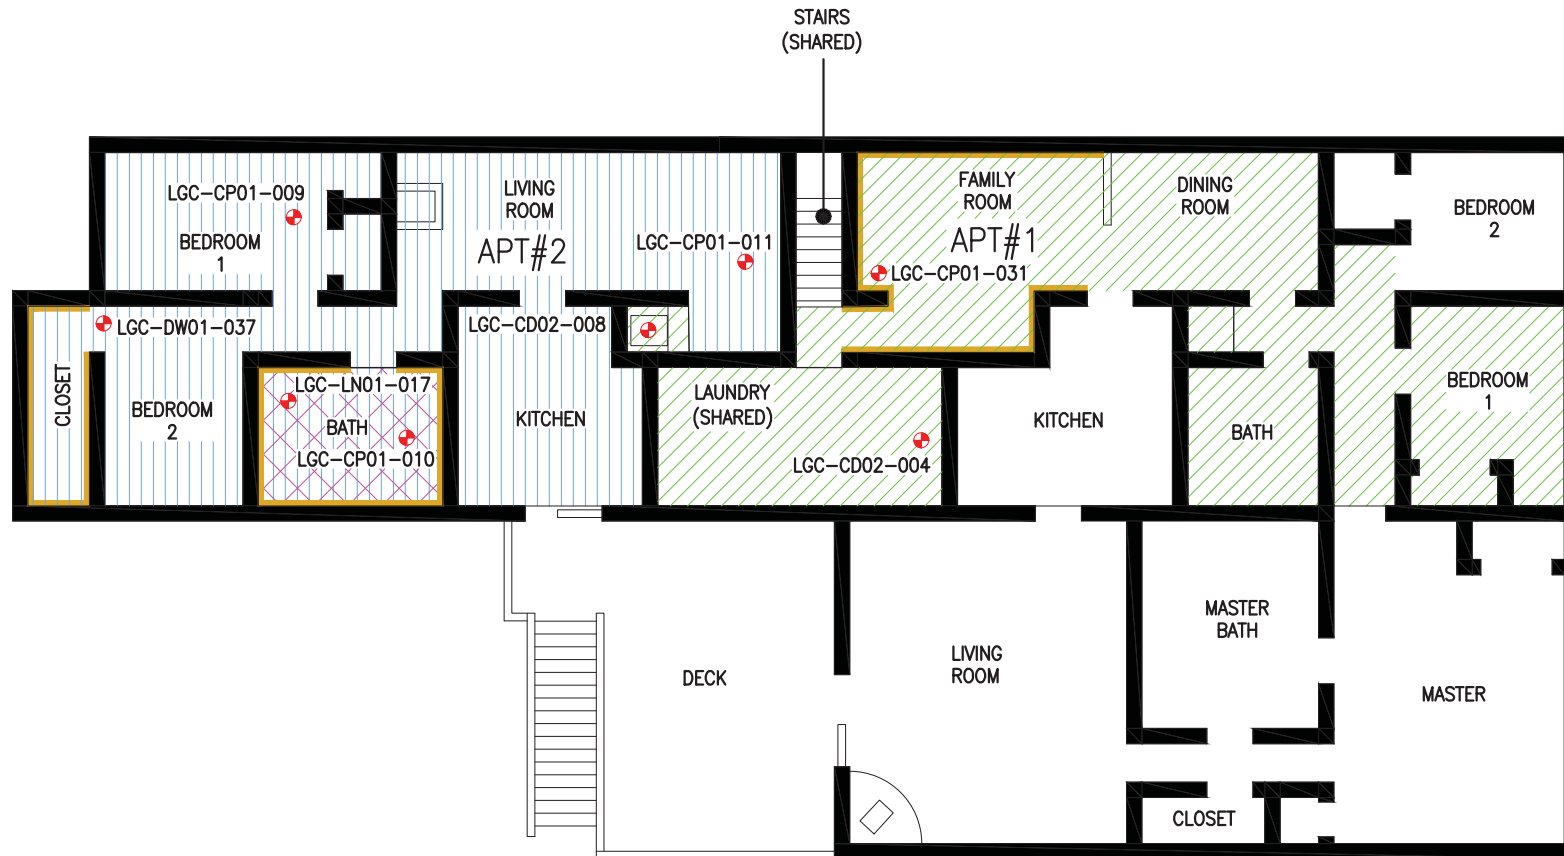
- ACM ASBESTOS CONTAINING MATERIAL
- ACM SAMPLE LOCATION (APPROXIMATE)
- ACM LINOLEUM EXTENT
- ACM CEILING PLASTER EXTENT
- ACM DRYWALL CEILING EXTENT
- ACM DRYWALL

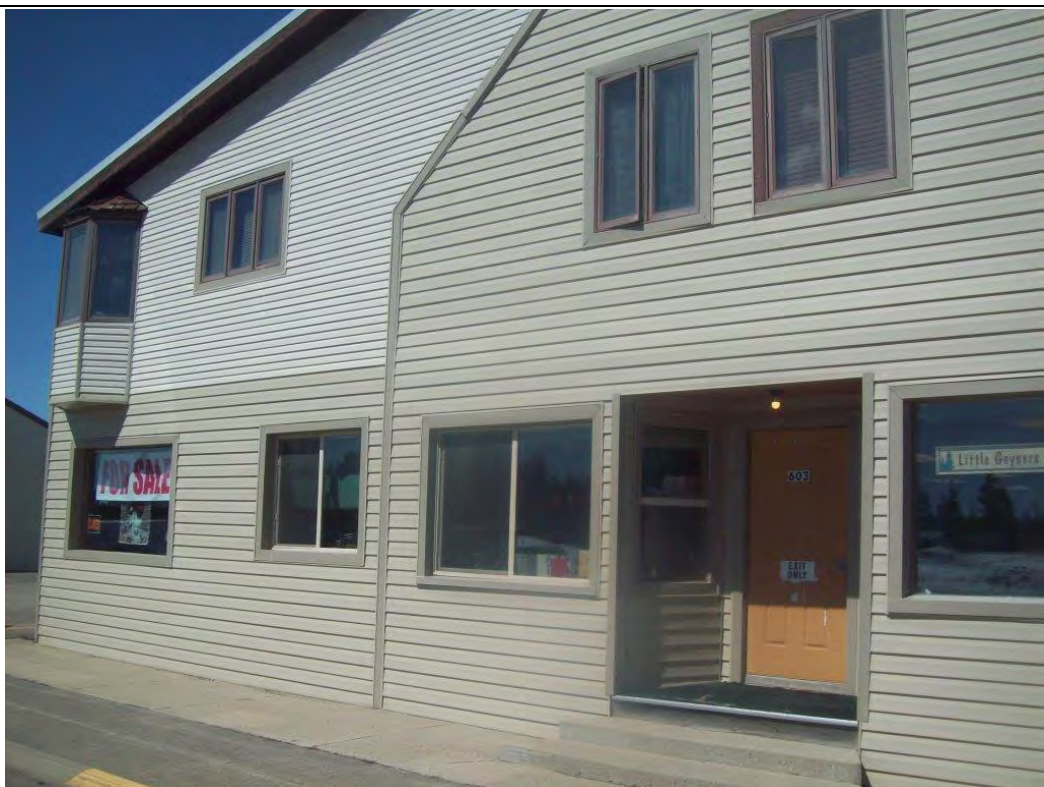
Photo No. 1	Date: 04/16/2016

Description:  Street view of south end facade of the Little Geysers Childcare Center.		
Photo No. 2	Date: 04/16/2016
